# Inspection Report

# PROPERTY INSPECTION REPORT

**Concerning:** \_\_\_\_\_ St, Round Rock, TX 78664  
(Address or Other Identification of Inspected Property)

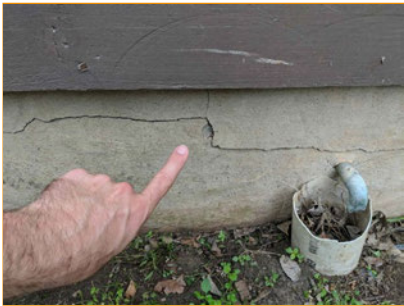
A. Item 1(Picture)

Cracks were observed in one or more areas. The advancement rate of hairline cracks cannot be determined from a one time visual inspection and we cannot determine when the cracks occurred or if they will progress. If the cracks advance a structural engineer or foundation specialist should be contacted. If you are concerned about the cracks, you should hire a structural engineer to evaluate.

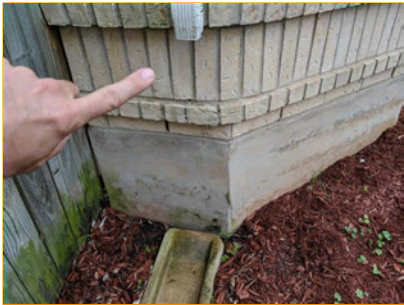
B. Item 1(Picture)

(1) Gutters should extending down to grade to prevent splash back. Recommend repair.

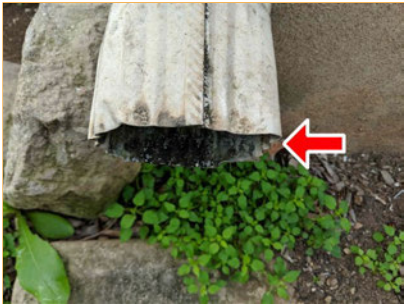
B. Item 2(Picture)

(2) One or more gutter diverters are missing.

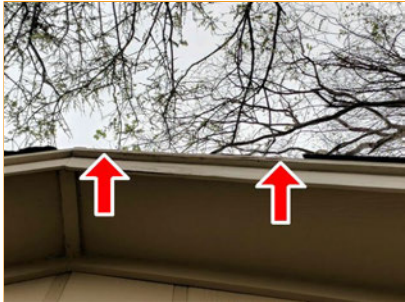
C. Item 2(Picture)

(3) There was no drip edge flashing observed at the roof perimeter. R905.2.8.5 Drip Edge. A drip edge shall be provided at eaves and gables of shingle roofs. Adjacent pieces of drip edge shall be overlapped a minimum of 2 inches (51 mm). Drip edges shall extend a minimum of 0.25 inch (6.4 mm) below the roof sheathing and extend up the roof deck a minimum of 2 inches (51 mm). Drip edges shall be mechanically fastened to the roof deck at a maximum of 12 inches (305 mm) on center with fasteners as specified in Section R905.2.5. Underlayment shall be installed over the drip edge along eaves and under the drip edge on gables. Unless specified differently by the shingle manufacturer, shingles are permitted to be flush with the drip edge.

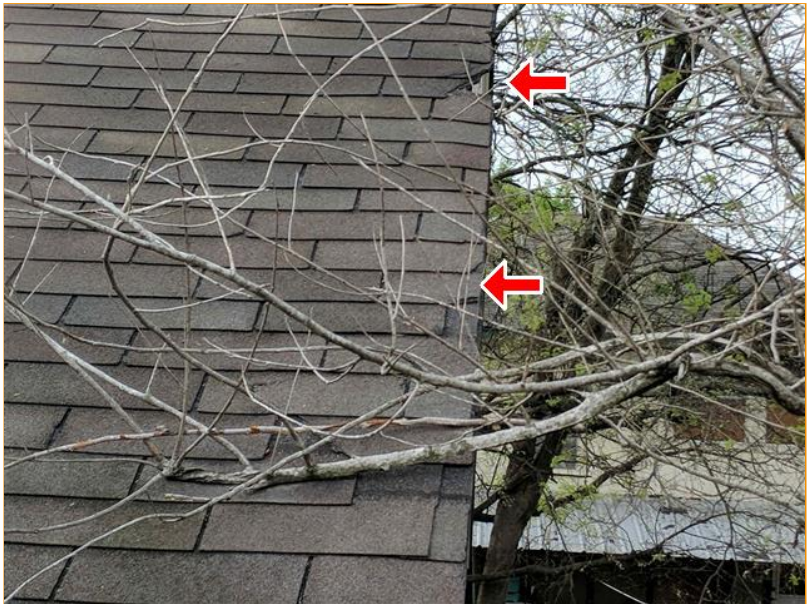
C. Item 4(Picture)

(4) Damaged shingles a gable end edges of home.

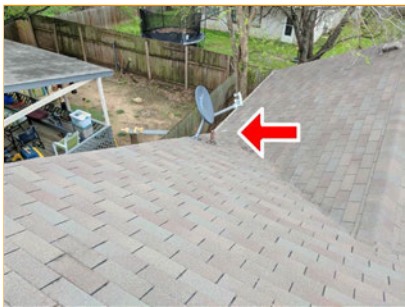
C. Item 5(Picture)

(5) Satellite dish was present on the house. It was attached to the roof through the roofing material. If not properly sealed leaks can occur. The inspector could not determine if a leak was present. Recommend monitoring the sealant around the connection points.

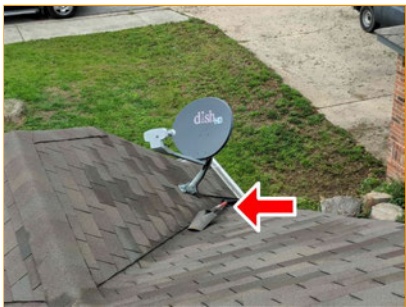
C. Item 7(Picture)

(6) The roof is missing granular material in one or more areas and should be further evaluated by a roofing contractor. Replacement of the roof or the damaged areas (if feasible) may be needed for insurability purposes. Inspector does not confirm insurability of the roof covering.

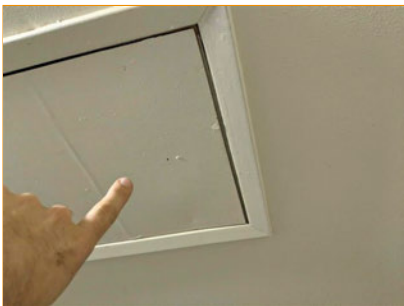
D. Item 1(Picture)

**Comments:**  
(1) Only areas of the attic determined accessible by the inspector are inspected. Insulation, HVAC ducts/ mechanical equipment, limited headroom, risk of ceiling damage, owner's belongings and wiring (electrical, cable and alarm) are examples of factors that may inhibit access. The inspector does not disturb insulation to locate footing.  
(2) Pull down string for attic access is missing

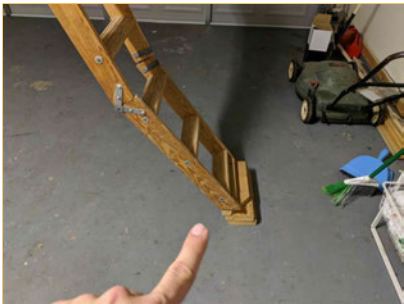
D. Item 2(Picture)

(3) Unable to locate fire retardant stamp/sticker at garage attic ladder. Attic access ladder may not meet today's fire separation code standards to separate garage from the living area R309.2 Separation Required "The garage shall be separated from the residence and its attic area by not less than ½-inch gypsum with a 45 minute burn rating"  
(4) Attic access ladder over extends when down and may be unsafe.

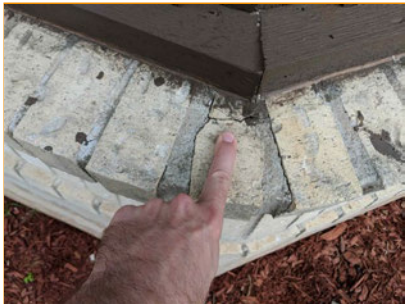
E. Item 1(Picture)

(1) Settlement at one or more exterior/interior wall areas. We do not know when the cracks occurred, if they will grow larger or if new cracks will appear in the future. If pictures are present, they are examples and may not represent all cracks in the home.

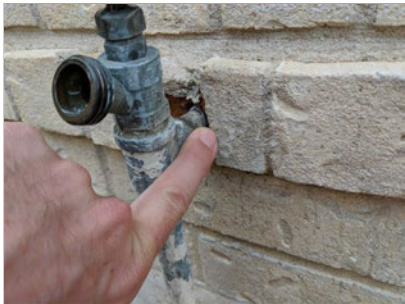
E. Item 2(Picture)

(2) Seal around exterior wall penetrations where needed

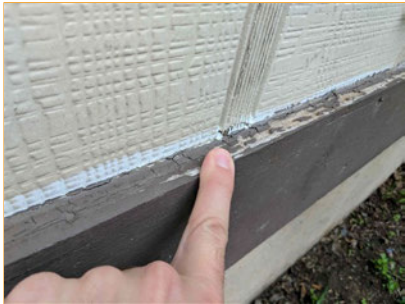
E. Item 7(Picture)

(4) The paint is failing and/or worn at various areas of exterior wood. I recommend prep and paint at all exposed areas to prevent rot

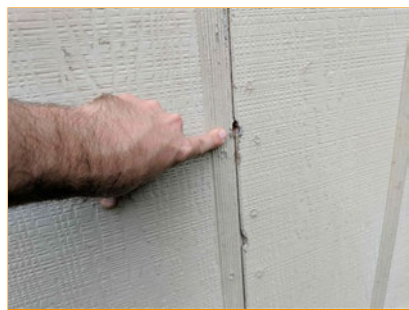
E. Item 8(Picture)

(5) Damaged siding at multiple areas on exterior of home. Recommend replacing damage building materials. Further damage may be present behind the siding that the inspector is unable to see.

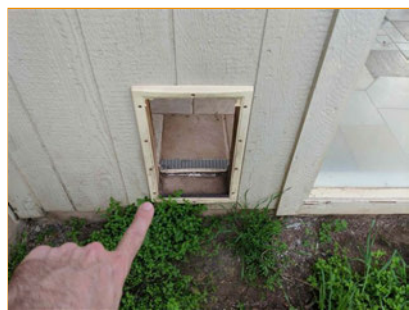
E. Item 11(Picture)

(6) Pet door has been cut in one or more walls. This diminishes is the fire rating of the walls and can leak conditioned air to exterior and can allow pest intrusion.

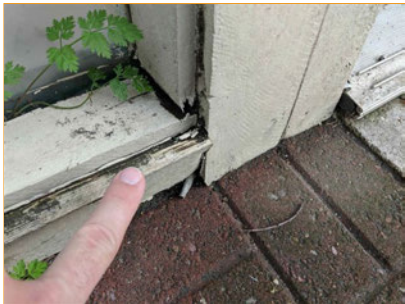
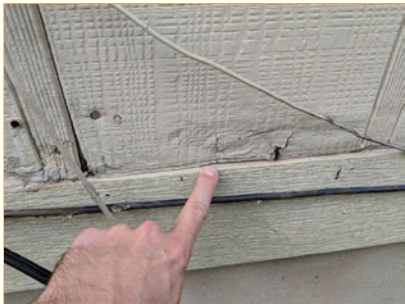
E. Item 12(Picture)

(7) Rot at wood trim and siding in various areas. Included pictures are examples and do not represent all areas needing repair

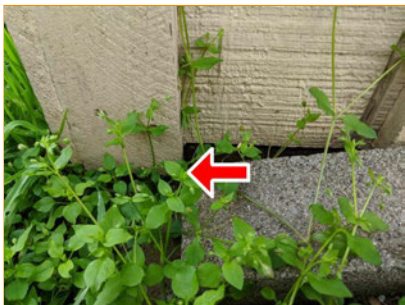
E. Item 15(Picture)

(8) Siding in contact with ground in some areas. Because the siding is in contact with ground it is possible for framing to be deteriorated. We did not inspect behind this siding. Recommend a ground clearance of six to eight inches where possible.

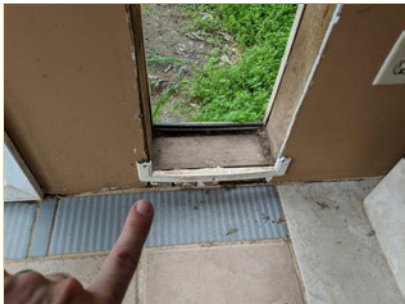
E. Item 16(Picture)

(9) Damaged drywall and water heater closet. Evidence of previous moisture damage. Recommend replacing damaged building materials. There may be further damage that the inspector is unable to see.  
(10) Evidence of water penetration and damaged interior drywall. Recommend replacing all damaged building materials. Further damage may be present that the inspector is unable to see.

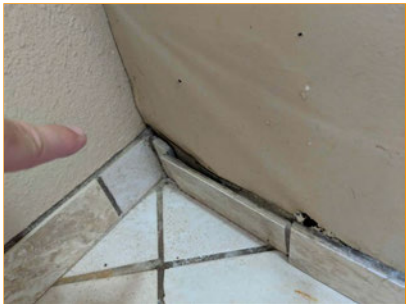
E. Item 19(Picture)

(11) Signs of fungi growth is present in several areas. We did not inspect, test or determine if this growth is or is not a health hazard. The underlying cause is moisture. I recommend you contact a mold inspector or expert for investigation or correction if needed.

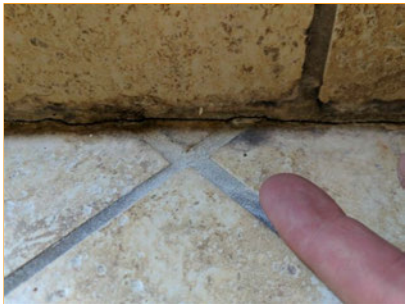
E. Item 21(Picture)

(12) Discoloration/mildew at caulk around one or more shower drain pan and/or tub perimeters may indicate a need to re-caulk these areas. Moisture may be getting behind the caulk causing the discoloration. It is important to keep all wet area corners and areas around wet area fixtures well sealed to prevent water damage. Damage can be present behind these areas that is not visible to inspector. The inspector does not perform destructive testing or investigation. Repair as needed.

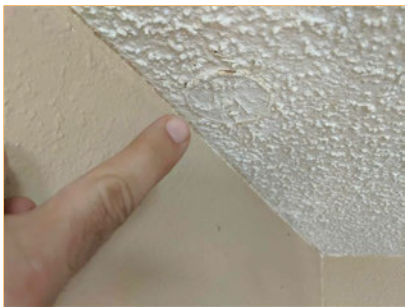
F. Item 1(Picture)

- (1) Floor coverings/furniture/rugs can conceal floor defects. The inspector does not pull back large rugs or move furniture.
- (2) Water stain observed at one or more ceiling areas. We do not know when the stain occurred or if it will continue. Repair the source of moisture if needed. Replace damaged building materials. Damage may be present that is not visible to inspector.

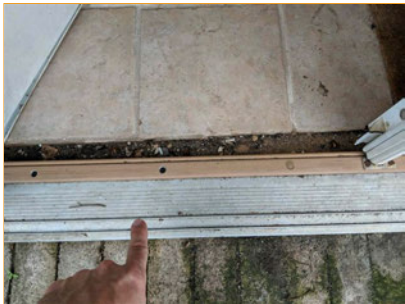
G. Item 1(Picture)

- (1) One or more door thresholds are loose and needs repair

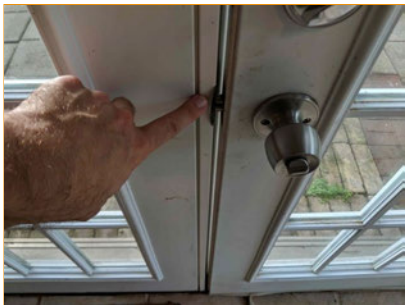
G. Item 3(Picture)

(3) Rear entry door does not latch

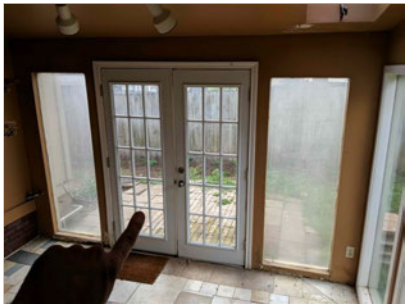
G. Item 5(Picture)

(5) French doors can be problematic and leak water to the interior. A roof or porch covering is recommended over all doors. Monitor these doors in wet weather. French doors are rear of home are difficult to open.

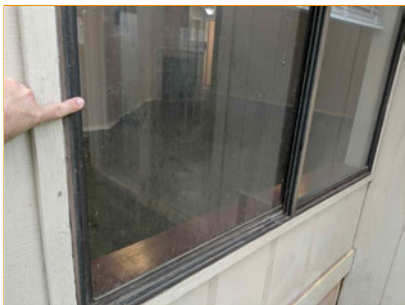
H. Item 1(Picture)

- (1) One or more windows were obstructed and could not be inspected/opened/closed. The inspector does not climb on or move furniture to test or inspect windows.
- (2) Missing one or more window screens.

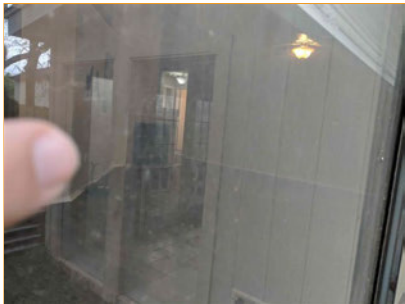
H. Item 2(Picture)

(3) One or more windows appear fogged. (ie moisture between panes or signs of previous moisture between panes). Double pane window seals may be broken without having a visible amount of condensation built up between the panes. Obviously fogged windows are noted when observed but complete inspection is not possible due to light conditions, installed screens, dirt on surfaces and/or rain at time of inspection. Consult a glass installer for further evaluation of windows in the event of any insulated glass failure prior to closing. If the house is occupied some windows may be inaccessible due to owner's belongings.

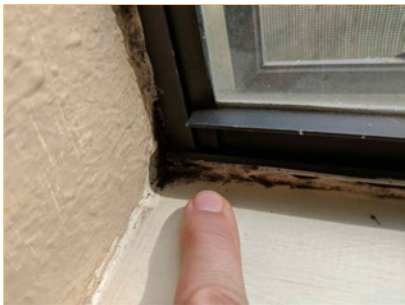
H. Item 3(Picture)

(4) Mildew noted under various windows due to condensation. Clean as needed. If further evaluation is desired, a mold inspection is recommended. Damage may be present that is not visible to inspector.

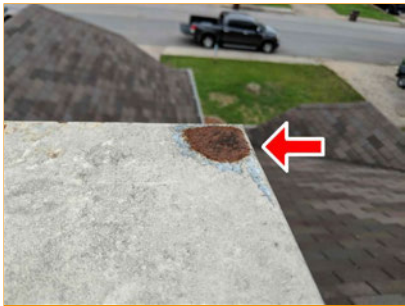
J. Item 1(Picture)

(2) Rust at chimney cap. Repair or replace to prevent leaks

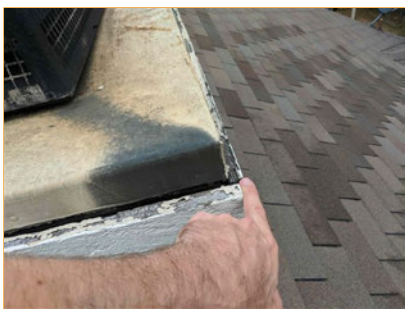
J. Item 2(Picture)

(3) Rot around chimney cap. Recommend replacing all damage building materials. Further damage may be present that the inspector is unable to see.

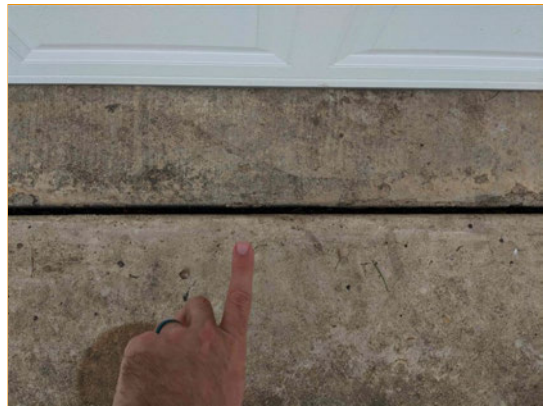
K. Item 1(Picture)

(1) Missing and deteriorated wood expansion joint material at various areas of driveway and front walkway. Seal these areas to prevent settlement of flatwork

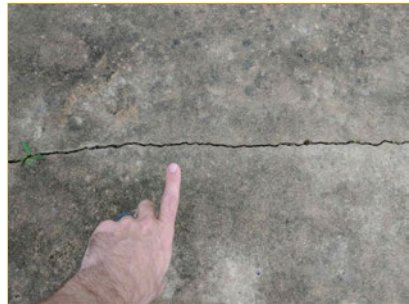
K. Item 2(Picture)

(2) Cracks noted at various areas of driveway, seal these areas to prevent settlement of flatwork

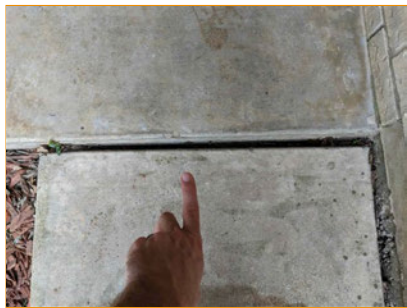
K. Item 3(Picture)

(3) Trip hazard near front door.

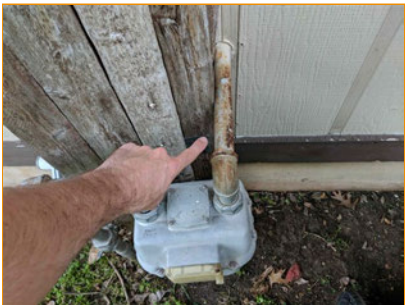
A. Item 1(Picture)

(1) Unable to locate gas line bond wire per today's code standards. Current code requires all exterior meters and interior unions to be bonded. This may have not been code when this home was built

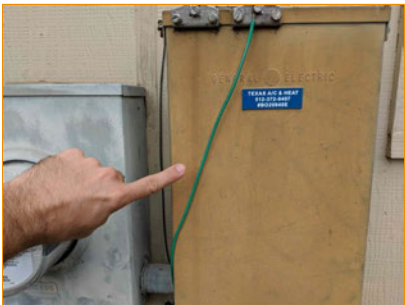
A. Item 2(Picture)

(2) Grounding wire blocks opening of exterior electrical panel. Recommend relocating grounding wire to new location.

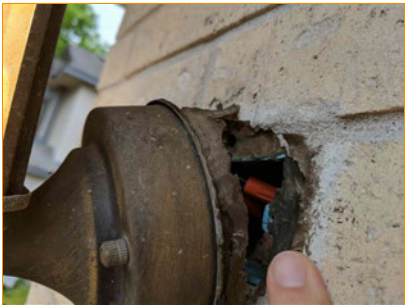
B. Item 1(Picture)

(1) Secure fixture to wall. Capped wiring should be secured inside of fixture. Ensure fixture is sealed to wall.

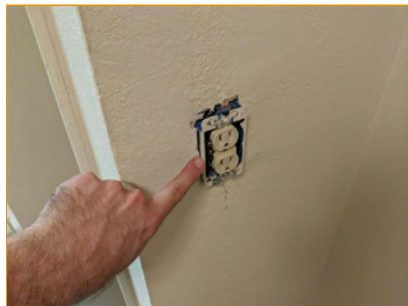
B. Item 2(Picture)

- (5) I did not locate a carbon monoxide detector in the home. It is recommended that one be installed according to the manufacturer's instructions. **R315.1 Carbon monoxide alarms.** An approved carbon monoxide alarm shall be installed outside of each separate sleeping area in the immediate vicinity of the bedrooms in *dwelling units* within which fuel-fired *appliances* are installed and in all dwelling units that have attached garages.
- (6) Smoke detectors do not function at the time of inspection.
- (7) Unsecured junction box in master bath closet. Recommend licensed electrician evaluate and repair.

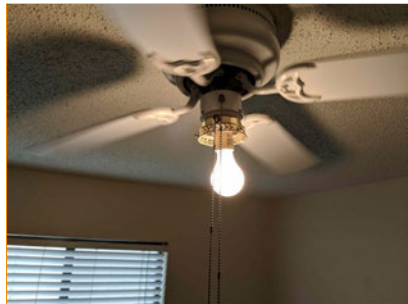
B. Item 3(Picture)

- (8) Missing bulb shields at various lights. Bulb shields recommended at all exposed bulbs.

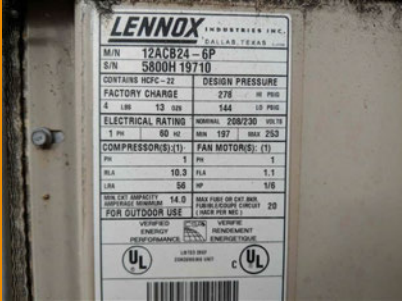
Outdoor compressor was manufactured in 2000. Inspector is unable to determine the tonnage of the unit. Delta T of 18 on heat mode. AC did not function at the time of inspection.

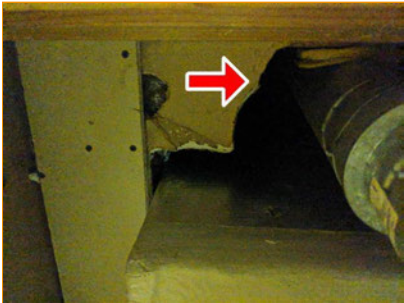
A. Item 1(Picture)

Comments:  
(1) Fully enclose ceiling of HVAC closet as a fire stop and introduce combustion and draft air vents from attic area.

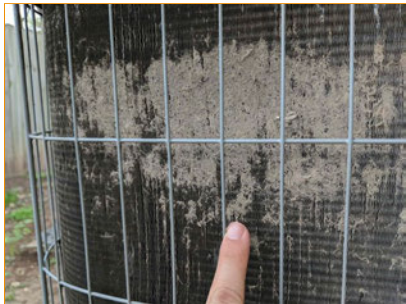
B. Item 3(Picture)

(6) The average life of an HVAC system is 15 years. The system(s) on the inspected home is/are over 15 years old. We cannot determine how long your systems will last, only how it performs at the time of the inspection.

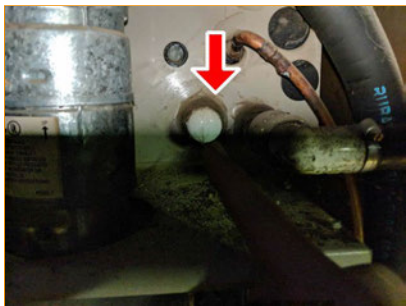
B. Item 4(Picture)

(7) Missing safety float sensor at condensate drain line in HVAC closet. Have a licensed HVAC contractor install to prevent water damage.

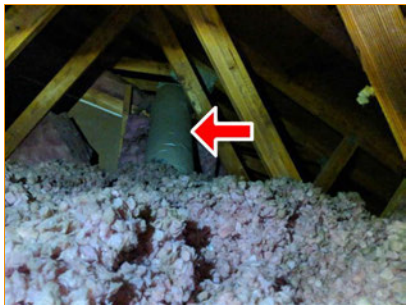
C. Item 2(Picture)

(3) Current standards would require ducting to be suspended above insulation

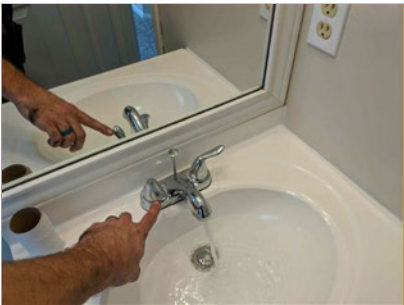
A. Item 1(Picture)

**Comments:**  
(1) Active leak under master bath sink. Recommend a licensed plumber evaluate and repair.  
(2) Faucet loose at hallway bathroom.

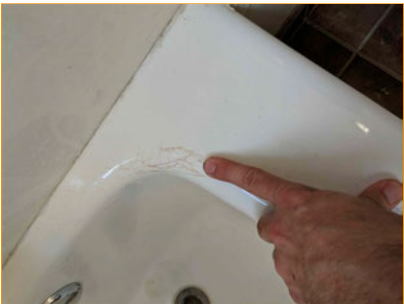
A. Item 2(Picture)

(3) Tub has cracks in hallway bathroom.

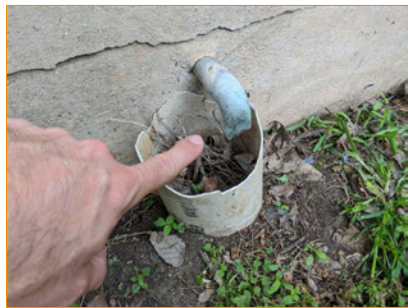
B. Item 1(Picture)

(1) The end of the exterior drain line has been deformed. Recommend returning opening to the original shape.

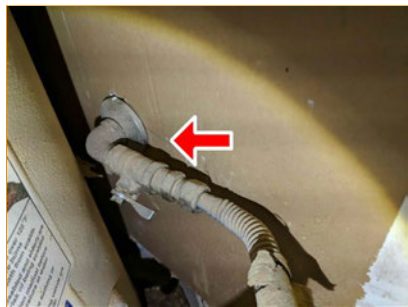
C. Item 2(Picture)

(2) Missing sediment trap at water heater gas supply line per today's code standards.

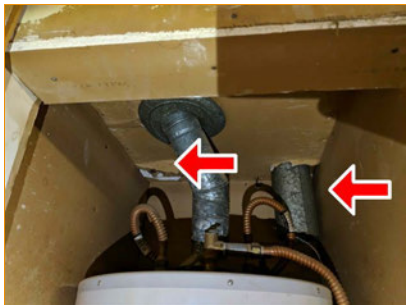
C. Item 4(Picture)

(5) Inadequate combustion or draft air vents for water heater closet.

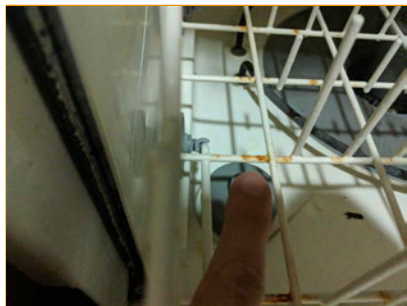
A. Item 1(Picture)

(1) Rust is present at various areas of dish baskets, replace as needed.

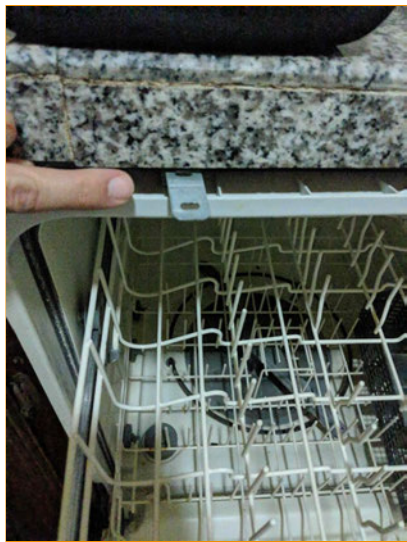
A. Item 2(Picture)

(2) The dishwasher is loose and needs securing to underside of countertop (using a proper length screw). I recommend repair as necessary.

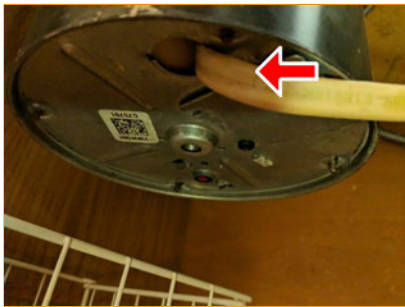
B. Item 1(Picture)

Comments:  
The food disposer wiring is missing a romex connector (anti-strain device). Repair as needed.

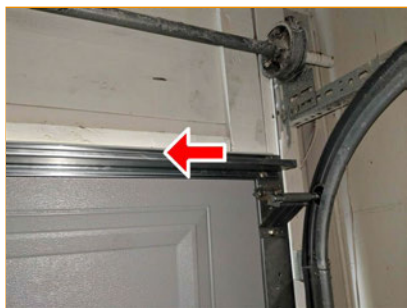
G. Item 2(Picture)

- (3) Daylight is present around over head door(s). Seal these areas to prevent pest intrusion
